HOME REPORT

76 BARFILLAN DRIVE
GLASGOW
G52 1BD

ENERGY PERFORMANCE CERTIFICATE

SINGLE SURVEY

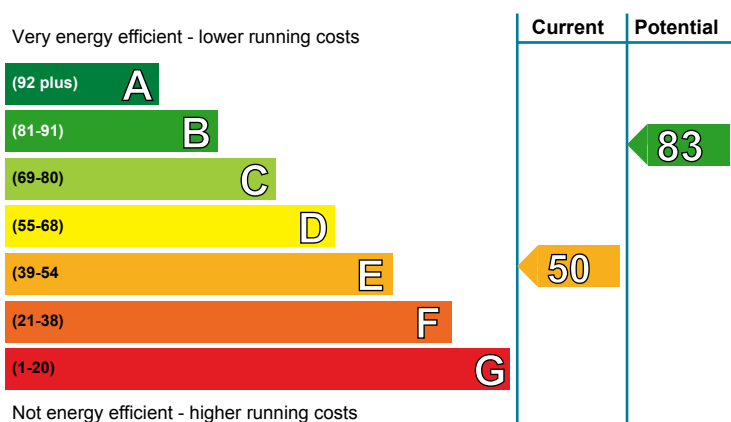
Energy Efficiency Rating

This graph shows the current efficiency of your home, taking into account both energy efficiency and fuel costs. The higher this rating, the lower your fuel bills are likely to be.

Your current rating is **band E (50)**. The average rating for EPCs in Scotland is **band D (61)**.

The potential rating shows the effect of undertaking all of the improvement measures listed within your recommendations report.

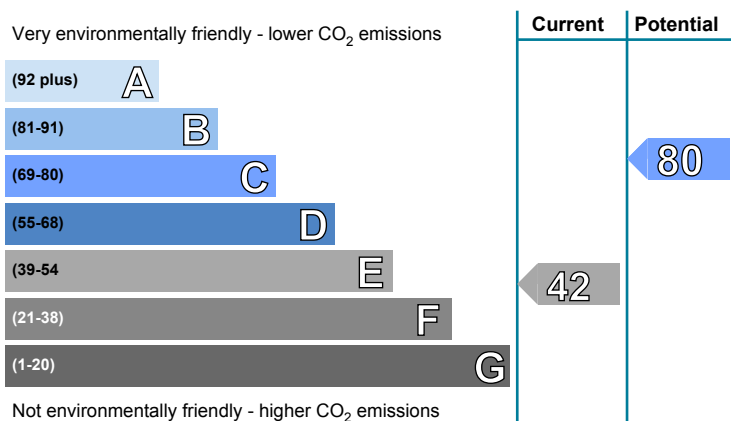
Environmental Impact (CO₂) Rating

This graph shows the effect of your home on the environment in terms of carbon dioxide (CO₂) emissions. The higher the rating, the less impact it has on the environment.

Your current rating is **band E (42)**. The average rating for EPCs in Scotland is **band D (59)**.

The potential rating shows the effect of undertaking all of the improvement measures listed within your recommendations report.
